TECHNICAL NOTE

No. 1132

AN ELECTRON-MICROSCOPE STUDY OF USED  
NITRIDED-STEEL PISTON RINGS

By Thomas P. Clark and Walter A. Vierthaler

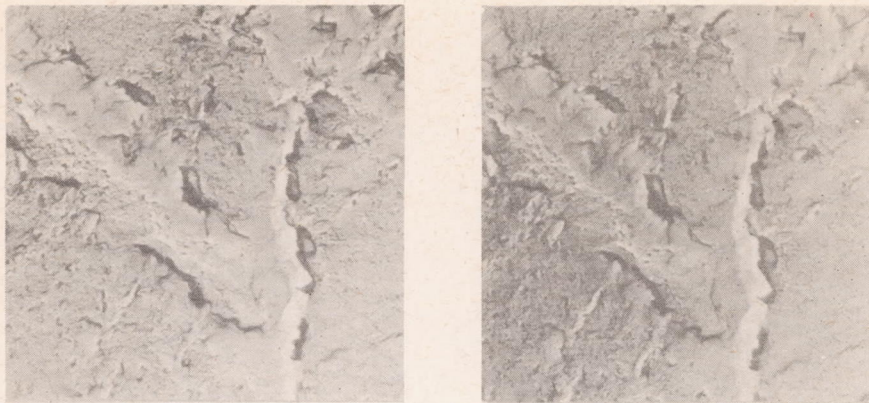
Figure 3. - Electron stereomicrograph of cross section of used nitrided-steel piston ring showing strained crystals and nitrided ridges just under surface of ring. Etched in nital. X6000.

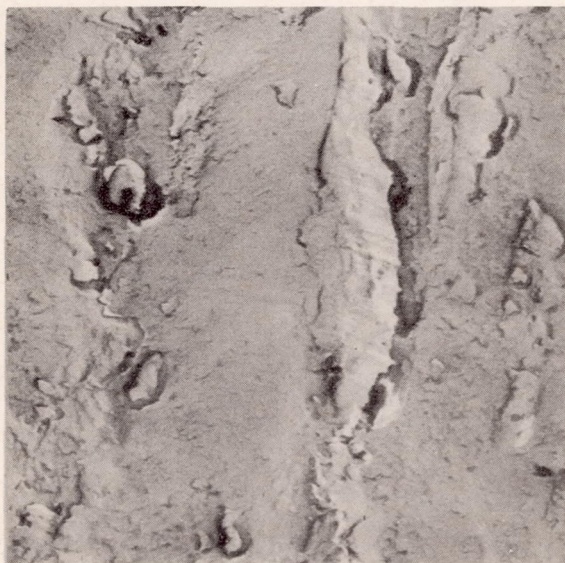
Figure 14. - Electron micrograph of cross section of used nitrided-steel piston ring showing nitrided case below worked-crystal area. Etched in nital. X10,000.

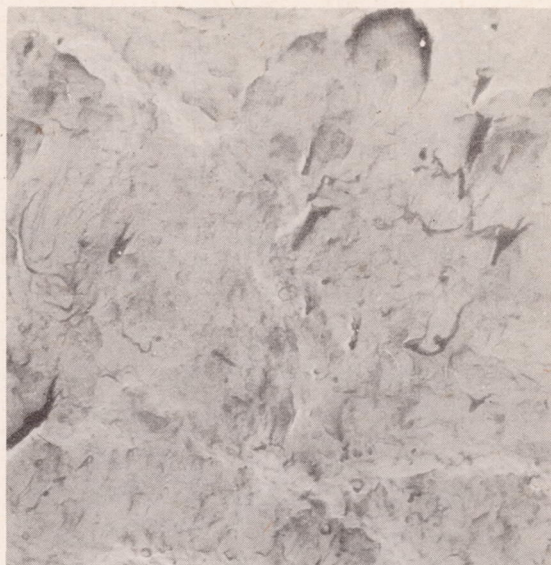
Figure 19. - Electron micrograph of running face of new nitrided-ring showing unworked surface area. Etched in potassium hydroxide. X10,000
